SOUTH SHORE FIRE STATION

Recommendation Report

2.7 SOUTH SHORE FIRE STATION 212 FACILITIES ASSESSMENT

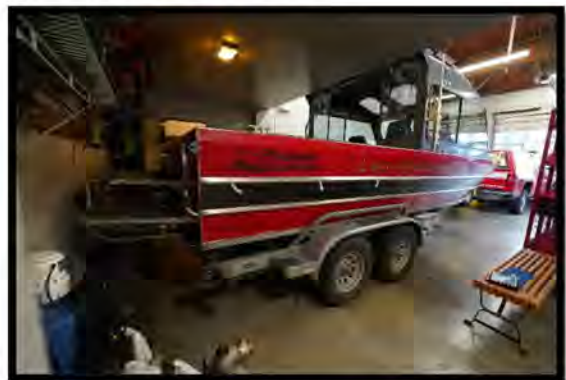
Figure 6. The rescue boat fits in the apparatus bay with less than three inches of clearance.

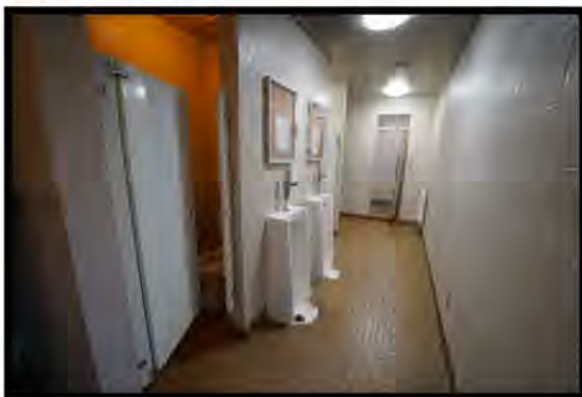
Figure 7. The group bathroom has two entrances and little separation between toilets and showers.

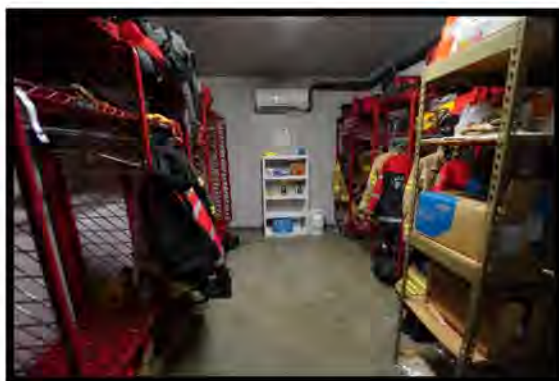
Turnout Room. Storage for the two sets of turnouts worn by firefighters on calls. Best practice is to store these in a separate room to mitigate the spread of carcinogens. The current station has been retrofitted to create a separate storage space, but it is undersized.

Figure 14. The existing turnout room is undersized.

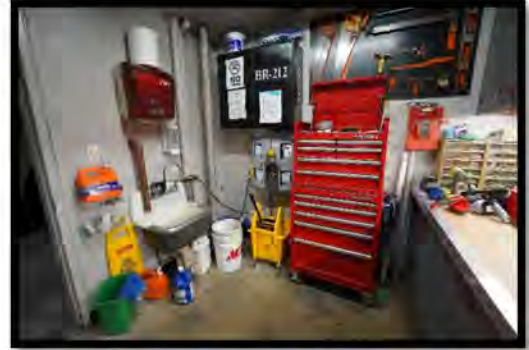
Figure 15. A cleaning closet doubles as the shop.

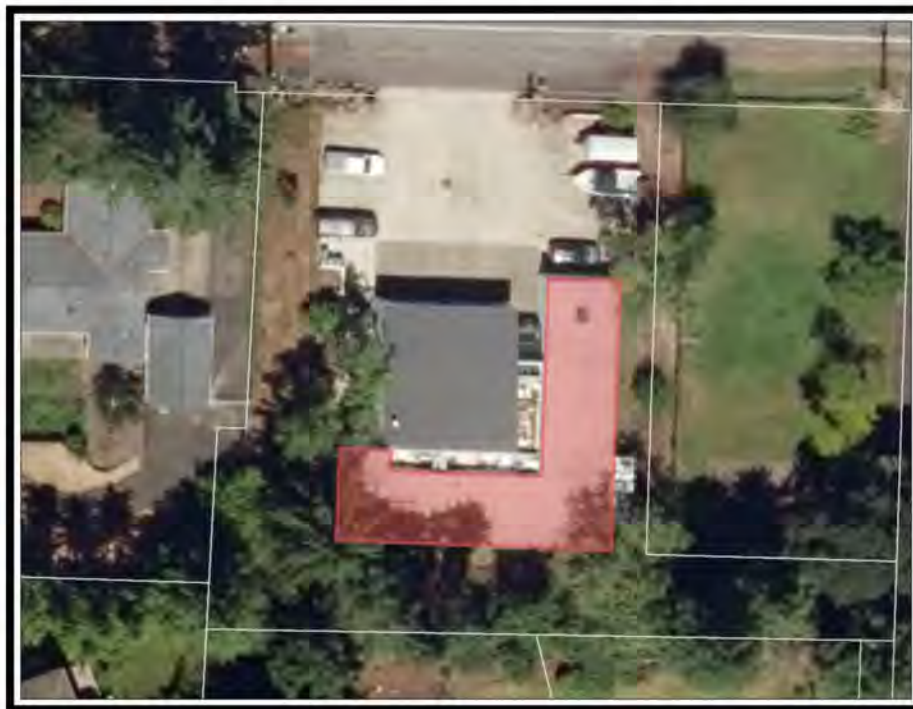
Living Quarters. Station 212’s living quarters are made of unreinforced cinder blocks. This is not seismically sound, and reinforcement would not be cost effective. Further, this space wraps around the back of the apparatus bay, making retrofitting a pull-through bay impossible. For these reasons alone, renovation of the living quarters is not recommended.

Apparatus Bay. The existing apparatus bay has been seismically reinforced. However, it is not the adequate length or width to accommodate the future needs of the companies housed at this station. If modified, it would be to such an extent that it is hard to imagine the existing reinforced bay offering any substantial cost savings. The bay is positioned near the back corner of the existing lot, making expansion infeasible and the possibility of a pull-through bay likely impossible.

Figure 26. At the existing facility, the living quarters (red) surround the apparatus bay.

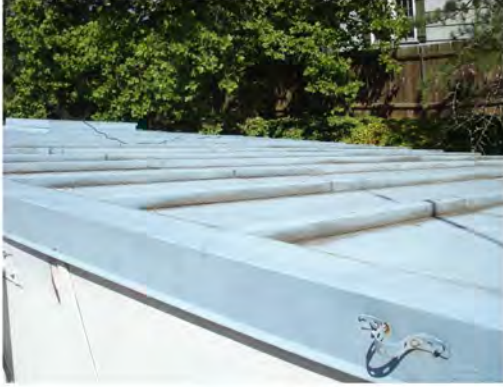
1.01

Area A: The metal roof system is aged and is deteriorating in areas.

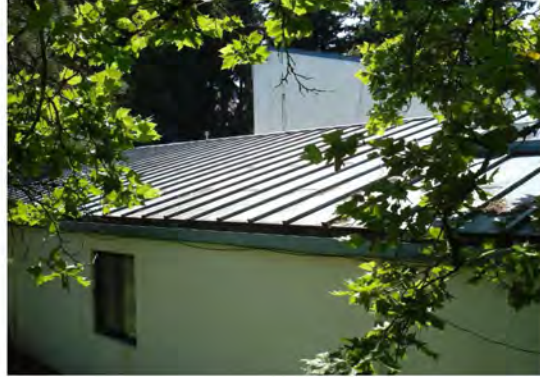
1.02

Area A: Photo of roof edge where the gutter and downspouts are deteriorated and are failing in areas..

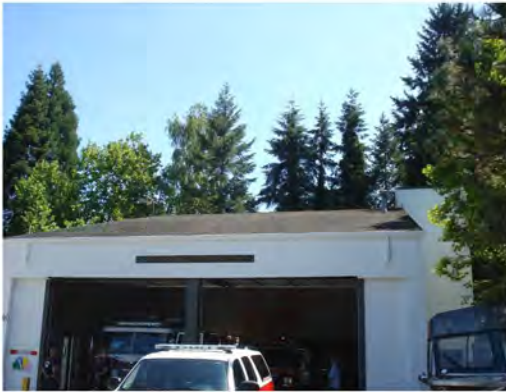
1.03

Area B: Photo of asphalt shingles servicing the garage area. Shingle roof system is performing well with no failures observed.

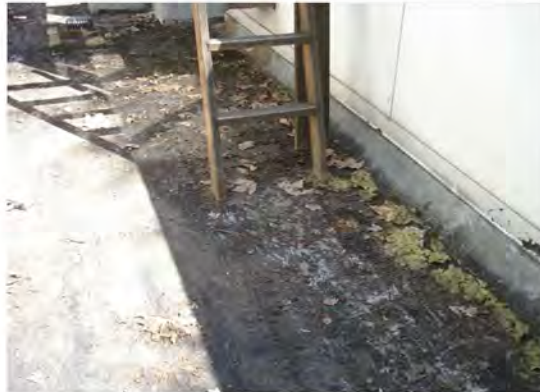
1.04

Area C: The roof area is failing at numerous locations and requires replacement in the very immediate future.

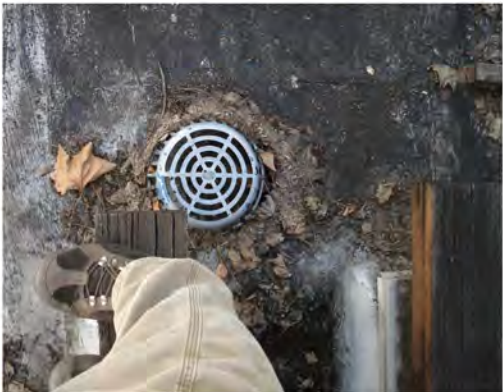
1.05

Area C: Drains are problematic due to the high level of tree leaves and other organic debris.

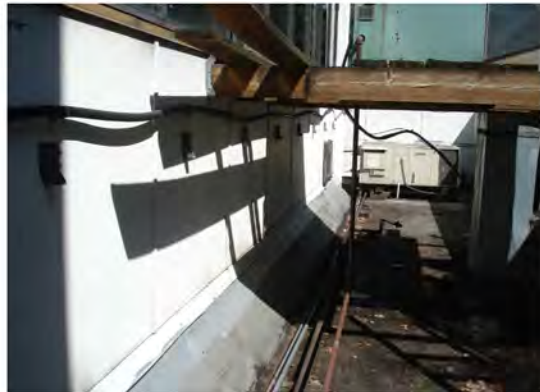
1.06

Area C: No overflow drains exist resulting in standing water as high as 3-inches deep over the entire roof surface.

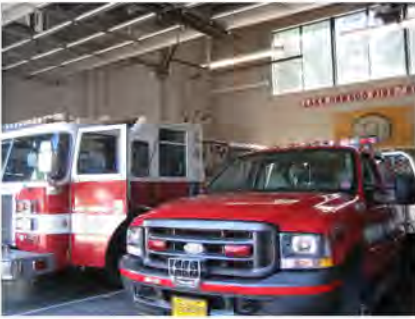
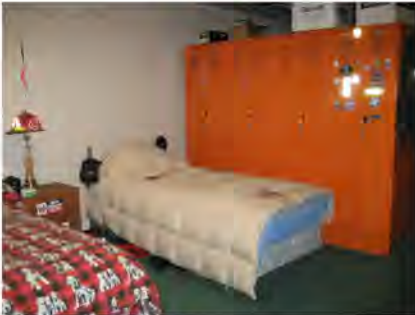
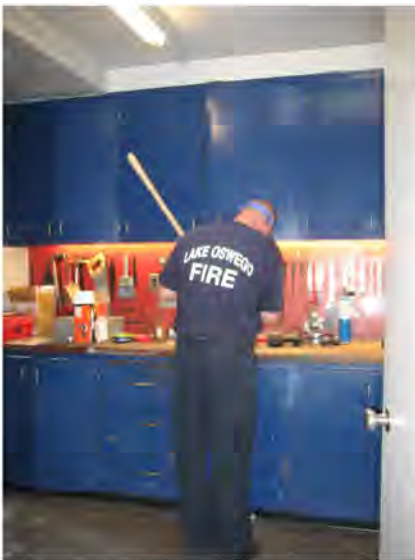
- The existing bay depth does not allow for an oversized ladder truck if this program element were required in the future.
- There is no conditioned turn out equipment storage space outside of the apparatus bay, causing premature degradation of the equipment caused by UV light exposure.
